DESCRIPTION OF SUBSTA. SITE

| WISCONSIN PUBLIC SERVICE CORP. | | | |
| PLAT OF ELCHO SUBSTATION<br>ELCHO, LANGLADE COUNTY WIS. | | | |

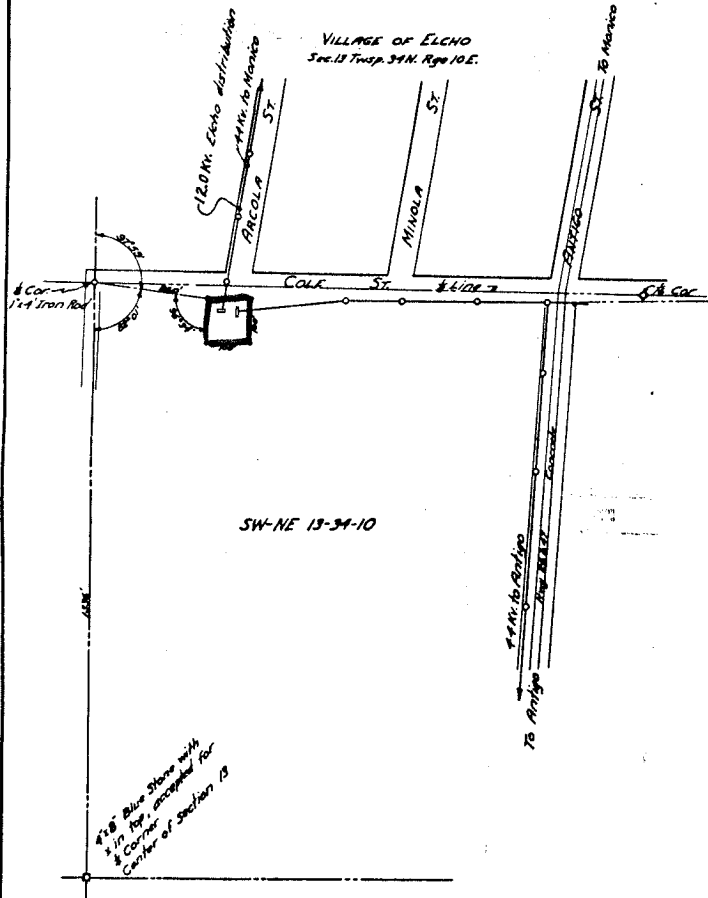
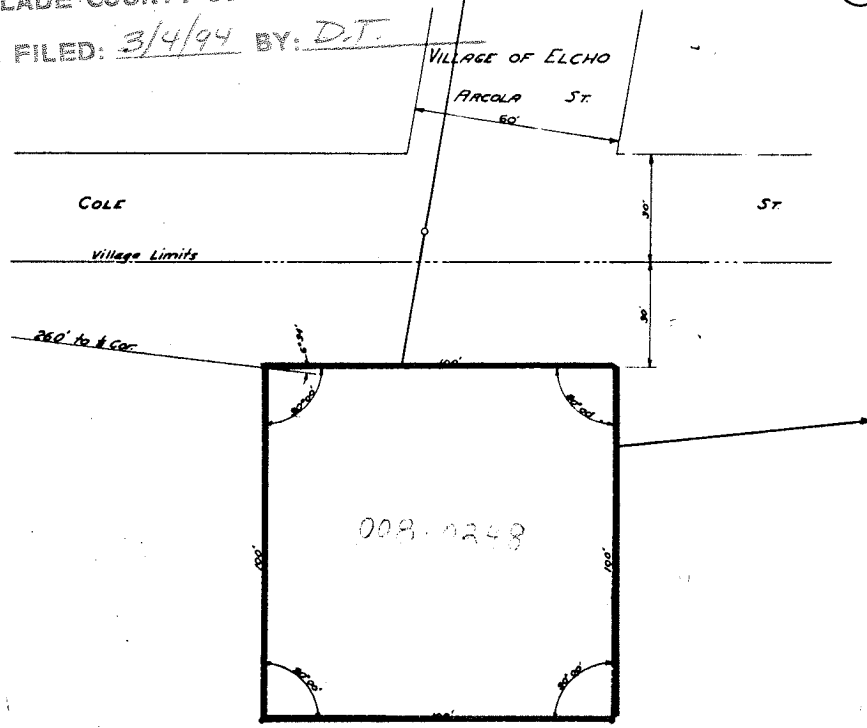
Commencing at the center of Section 13-34-10, A 4"x8" blue stone with x in top. Thence North on a section line 1336' to a section corner, a 1"x4" iron rod in the ground. Thence by an angle to the right of 97°33', 260' to an iron pipe in the ground, this is the place of beginning. Thence by an angle to the left of 6°34', 100' to an iron pipe in the ground. Thence by an angle to the right of 30°00', 100' to an iron pipe in the ground. Thence by an angle to the right of 30°00', 100' to an iron pipe in the ground. Thence by an angle to the right of 30°00', 100' to the place of beginning. All in the Township of Elcho, Langlade County, Wisconsin.
